*Newhouse, Ashreigny, North Devon: a cob and thatch farmstead.*

## Introduction

*This leaflet has been produced by the Technical Panel of the Devon Historic Buildings Trust.*

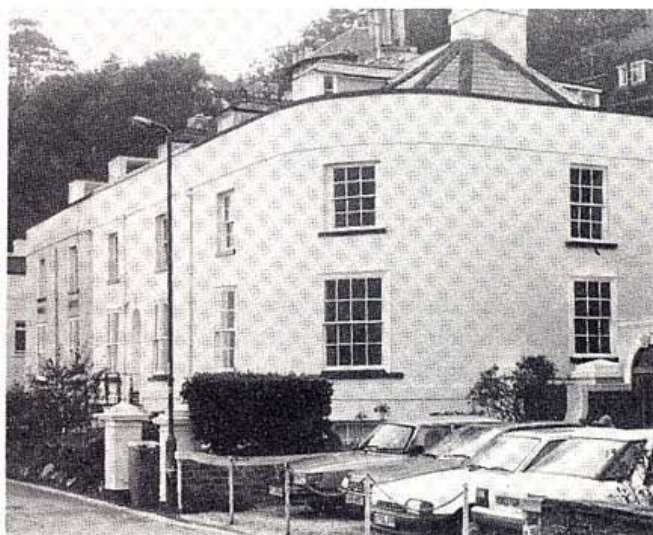
*Large 18th century cob warehouse at Shaldon, converted into seaside villas around 1830.*

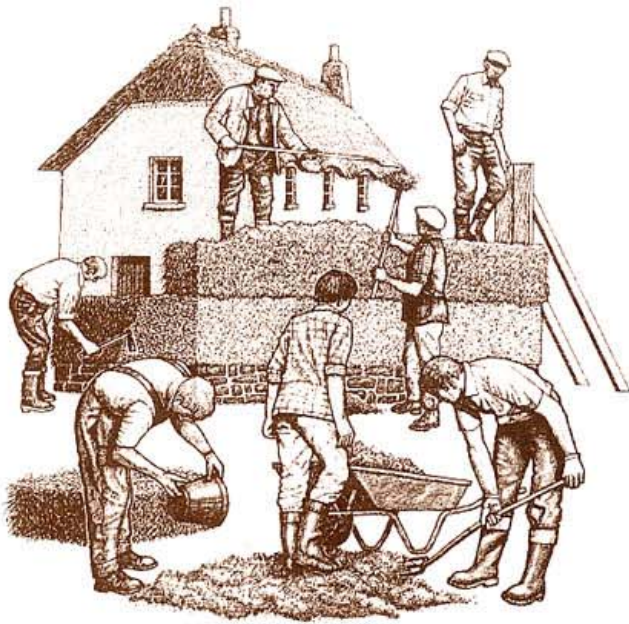
*Traditional method of cob construction showing mixing, placing material on the wall, compaction by treading and paring back the wall face.*

Cob walls are normally built off a stone plinth, which can vary in height from around 450 mm above ground level up to first floor joist level in some domestic buildings. Correct mixing of the material is as important as the actual construction process. The soil is first broken down to a fairly fine tilth, all large stones greater than about 50 mm dia. being removed in the process. It is then spread out in a bed some 100 mm in depth on a hard, pre-wetted surface on top of a thin layer of straw. Water is then added and a second, thicker layer of straw is spread evenly on top (about 25 kg of straw per cubic metre of soil – 1.5 to 2.0 % by weight – is considered adequate). The straw is then trodden into the soil which is turned several times, more water being added as required. Thorough treading of the mix (traditionally by either men or animals) is vital because it ensures even distribution of the clay and renders the material to a consistency and state of cohesion suitable for building. The quantity of water used will vary according to soil type but is usually in the range of 10 to 12% by weight. If too little water is added the necessary blending, in other words efficient distribution of the clay fraction throughout the soil, will be difficult to achieve; the material will also be difficult to compact when it is placed on the wall. On the other hand, excessive amounts of water reduce the soil to a soft, plastic state, making building virtually impossible. In this case the material may need to be left for several days to dry out before using.

In the South West the tool most usually employed in cob construction was a small fork with a slightly curved wooden handle about 1.2 m in length. It had three broad tines with sharpened tips and was used both to lift the

clods of earth onto the wall and then to beat and shape the material to the required form. Actually, much of the necessary compaction was achieved by the workman's boot, the material being placed in diagonal layers, well heeled in, and then thoroughly trodden between each lift. The height of a lift or 'raise' would vary according to soil type and consistency from 300 up to 900 mm. The material always overlapped the face of the stone plinth by at least 75 to 100 mm, the surplus being pared off after a few days, usually before commencing the next lift, with a special flat, sharp edged spade, known as a 'paring iron', or with a small mattock. The best cob walls are comprised of well-graded, moderately clayey soils containing plenty of small stones and straw, and have been well compacted. Such walls, if kept dry by means of a stone plinth and a roof with a good overhang at the eaves (ideally around 450 mm), will last for centuries.

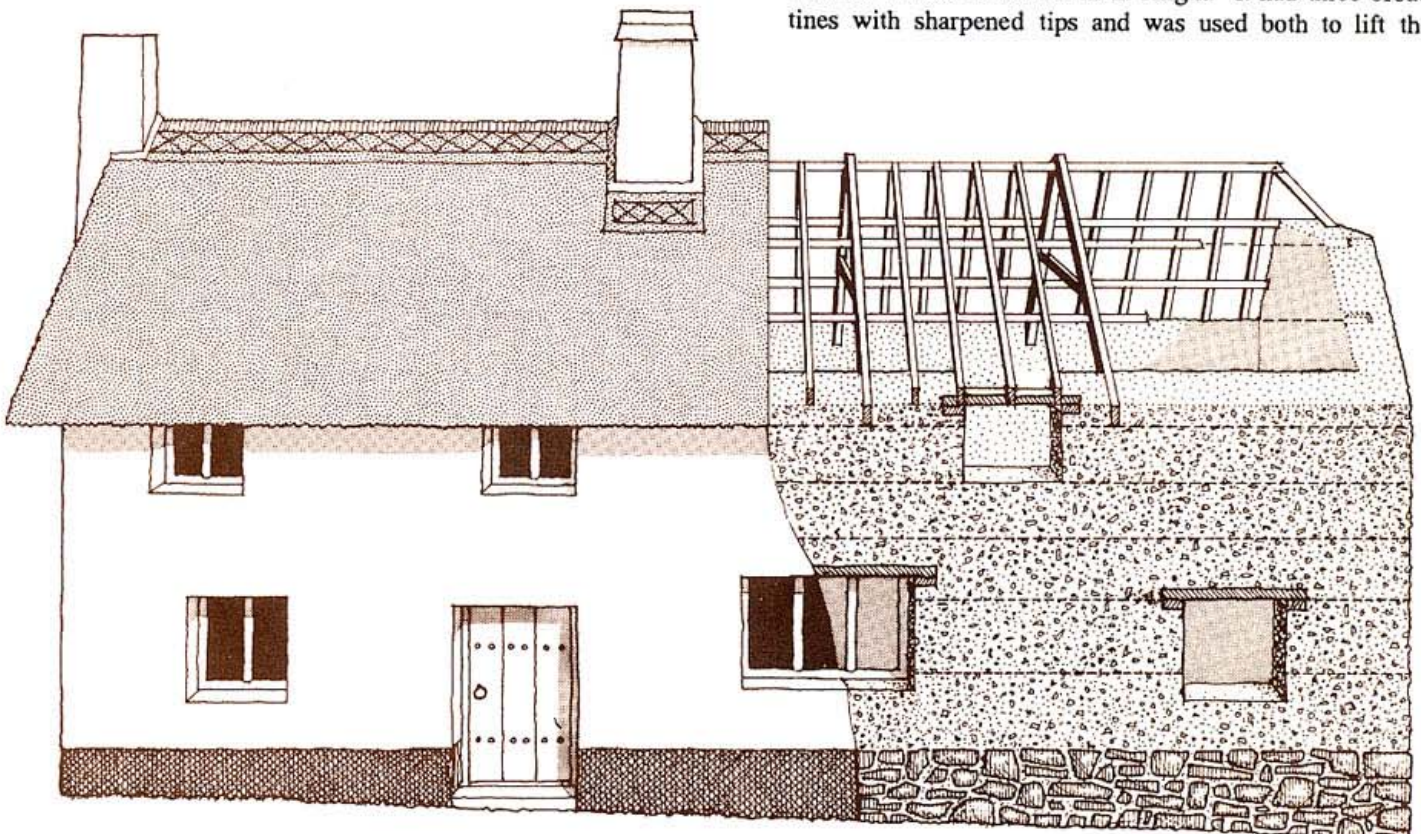
*A typical 17th century cob house showing some constructional details. The wall is built off a stone plinth in several layers, or lifts, and lintels and roof timbers are supported on the cob, using timber pads or cross pieces where necessary.*
