INTRODUCTION

The DHBT in its first leaflet on cob describes the history of the material and the way in which it was used in building. This second leaflet is intended to help those who have responsibility for cob buildings to maintain and repair them in the best way.

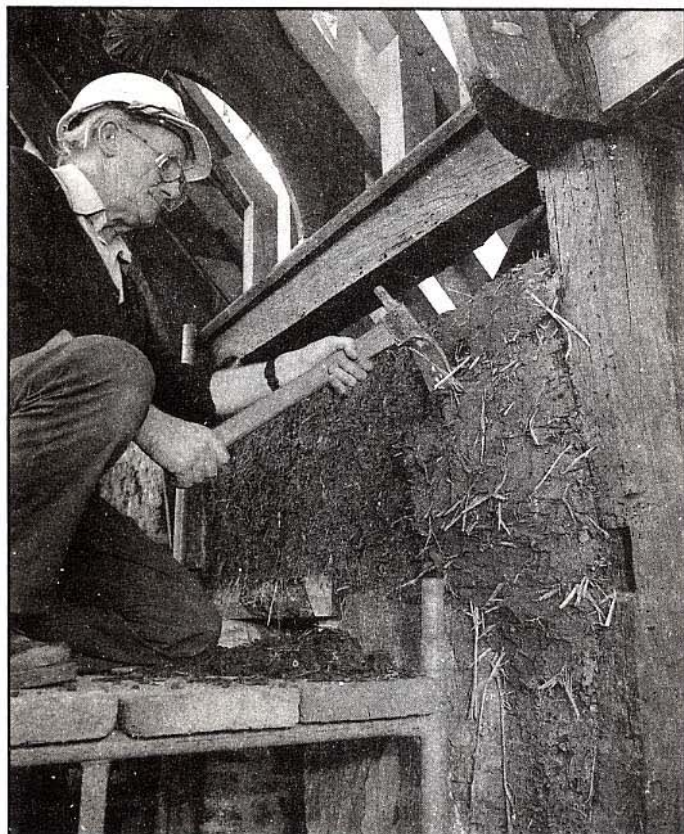
Paring back new cob inserted as a repair at Bowhill, Exeter.

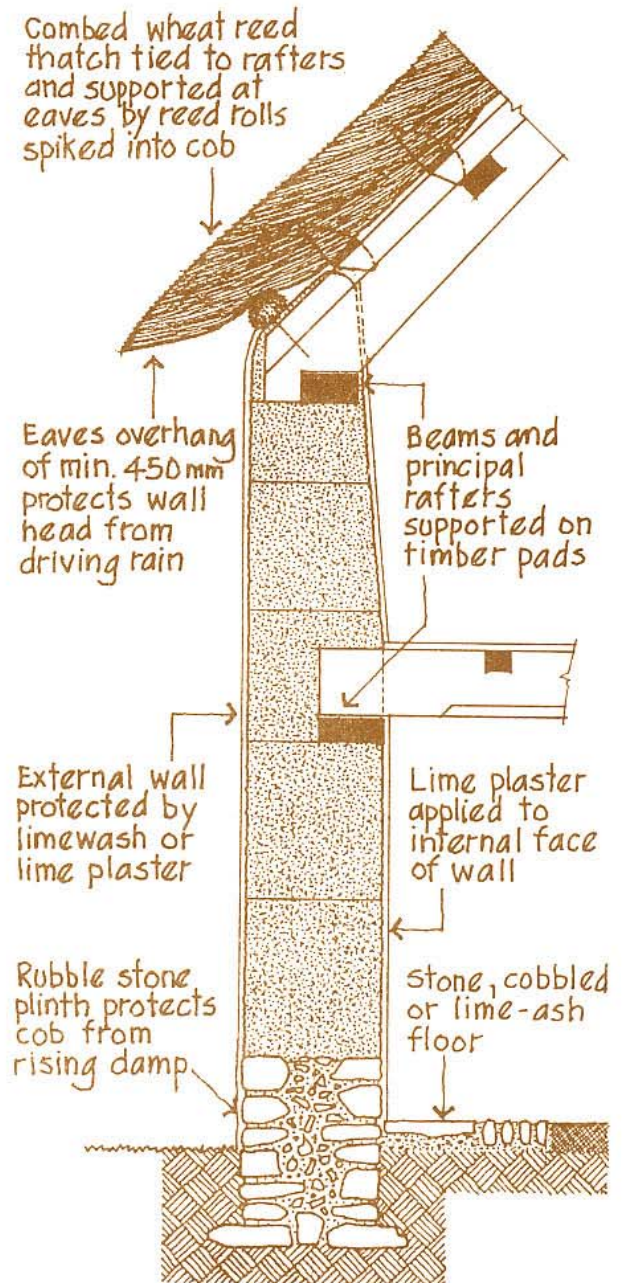
Fig 2. Enlarged cross-section through unaltered cob wall showing construction details.

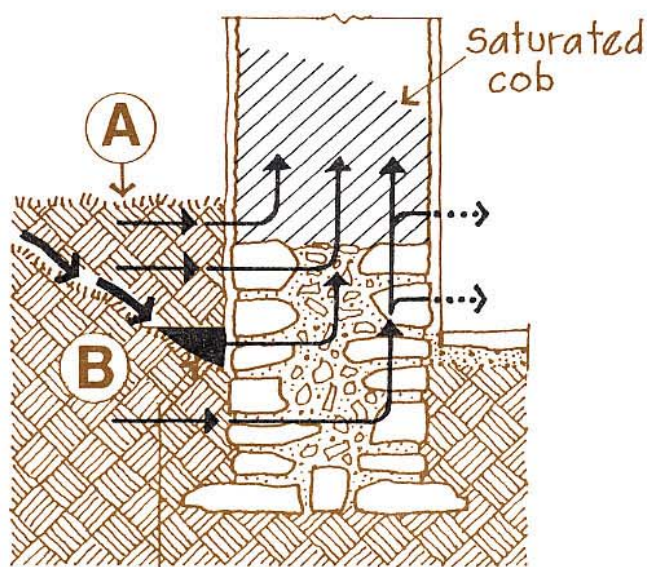
Fig. 3. Moisture penetration resulting from (A) raised ground level at foot of wall or (B) wall construction at bottom of gradient.

Standing water

- Capillary moisture movement
- Running water
-→ Water vapour

- Similar problems will occur in slated or tiled buildings where gutters and down-pipes are blocked or broken and overflow.
- v) Raising of the external ground level above the stone plinth, allowing the foot of the cob wall to become permanently damp, thus weakening the wall and reducing its load-bearing capacity at the point of greatest load.

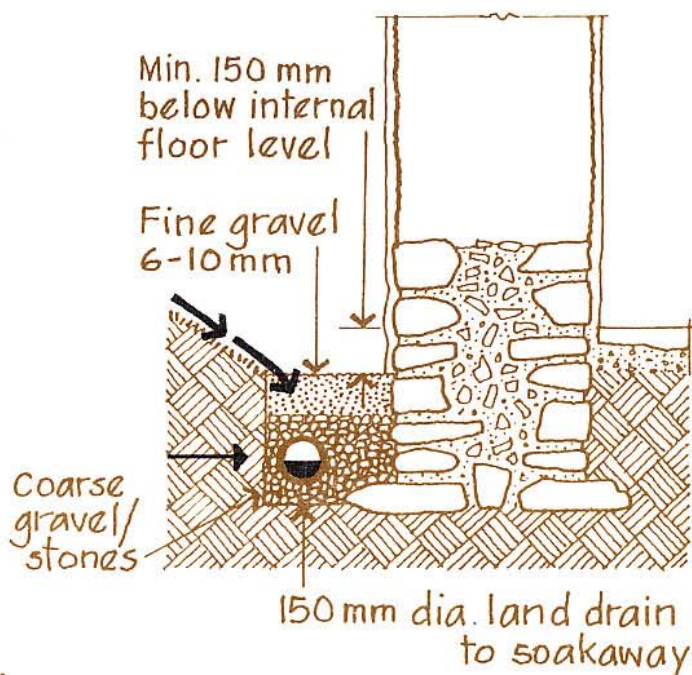
Fig 3b. Alleviation of damp problems by improved drainage.

Because cob walls are built off stone plinths, rising damp should not be a problem, as long as external land drainage is adequate. In particular a build-up of soil alongside or above the plinth may cause damp penetration; this should be able to be cured by a field drain as shown in Fig. 3b. Cob is a coarsely textured material containing many pore spaces, and capillary movement of moisture is very restricted. Tests have shown that vertical movement of moisture in an un-rendered cob wall will not normally exceed 150 to 250 mm. This means that injecting a chemical damp-proof course into the base of a cob wall may well be ineffective because, provided the cob is covered in a moisture-permeable render, moisture will not rise to the point where it becomes a problem. Moreover it should be emphasised that this method of damp-proofing, while usually successful in brick and solid masonry walls, is unlikely to be wholly effective in old random stone walls because of the large number of voids that often exist within their rubble-filled cores.

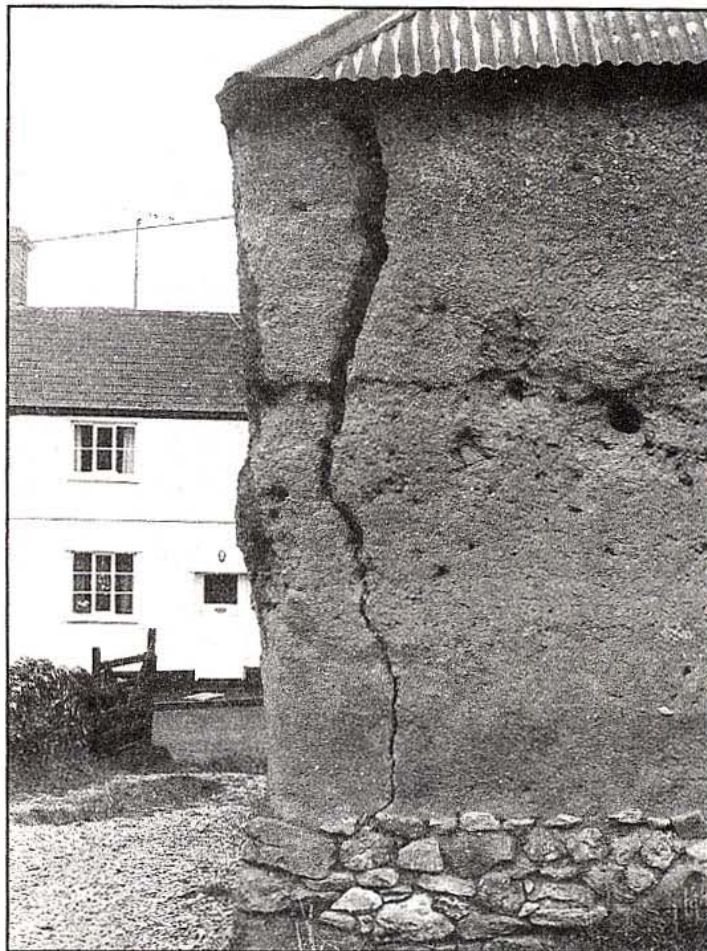
Typical structural crack in cob wall.

In the majority of surviving Devon Cob buildings the walls form an integral part of the structure and are fully load-bearing. Because the tensile strength of cob is relatively low, any significant movement in either the roof structure or the stone plinth is likely to result in the development of cracks and fissures in the wall. In the most common form of failure, the gable wall will become detached from the lateral walls. (see Illustration). Full-height cracks will appear which become progressively wider as they near the top of the wall - an indication that the wall is being pushed out by the roof timbers - in the illustrated case as a result of 'racking'. No attempt should be made to repair a structural crack unless the wall is known to have stabilised and there is a reasonable certainty that all movement has ceased.

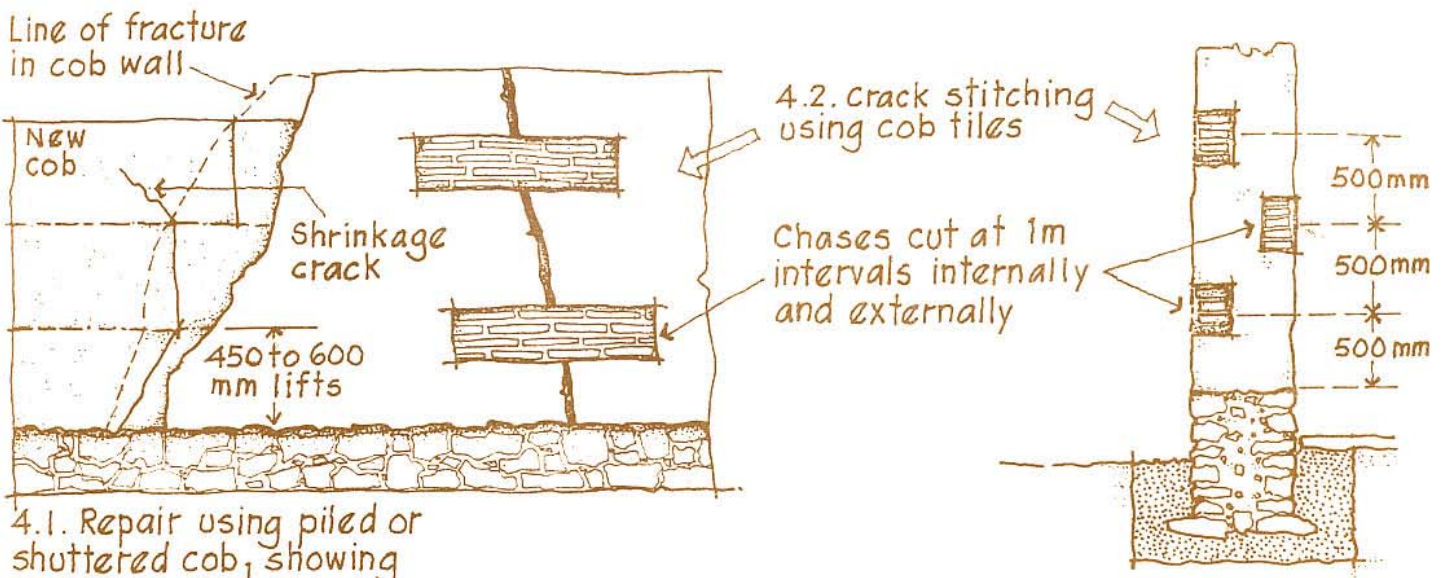
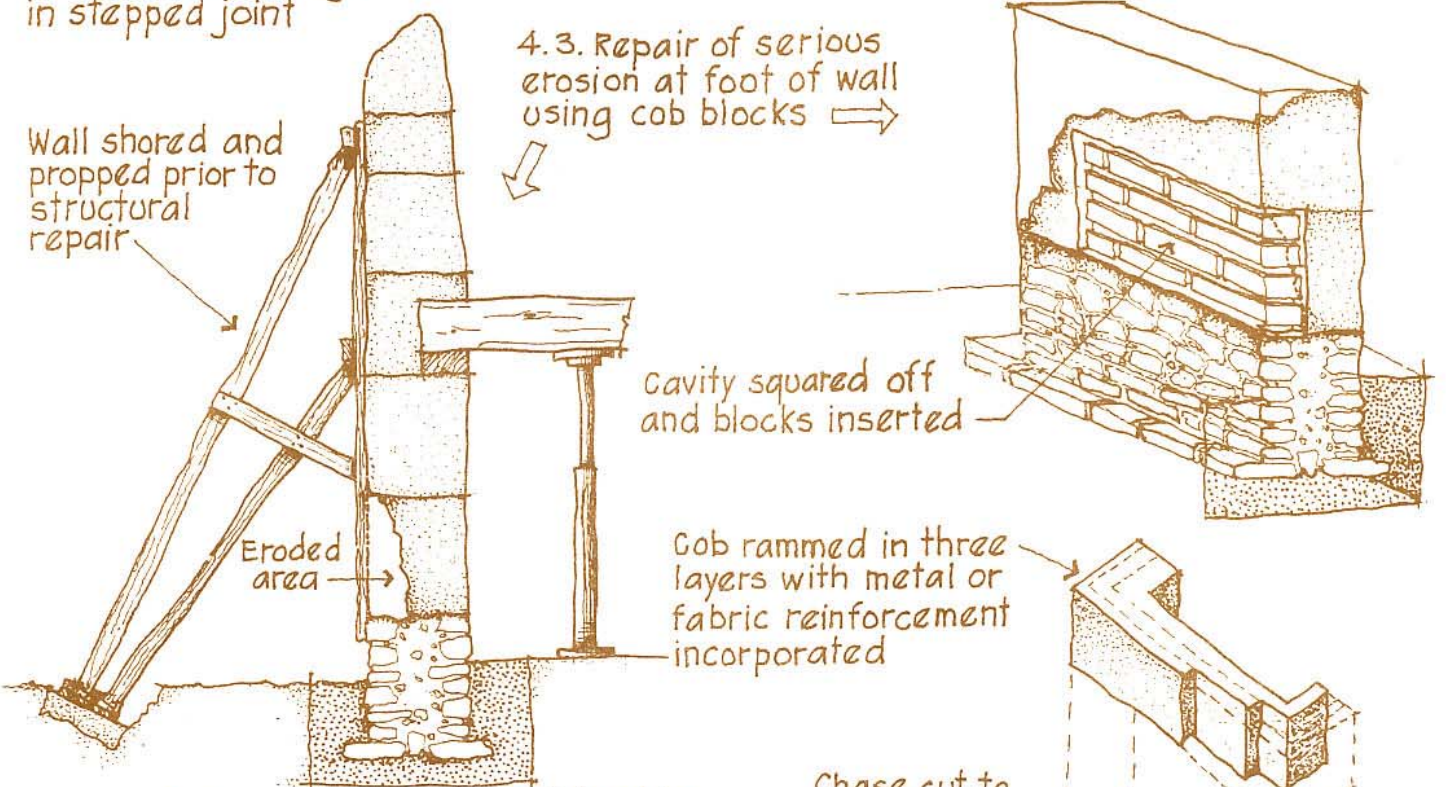
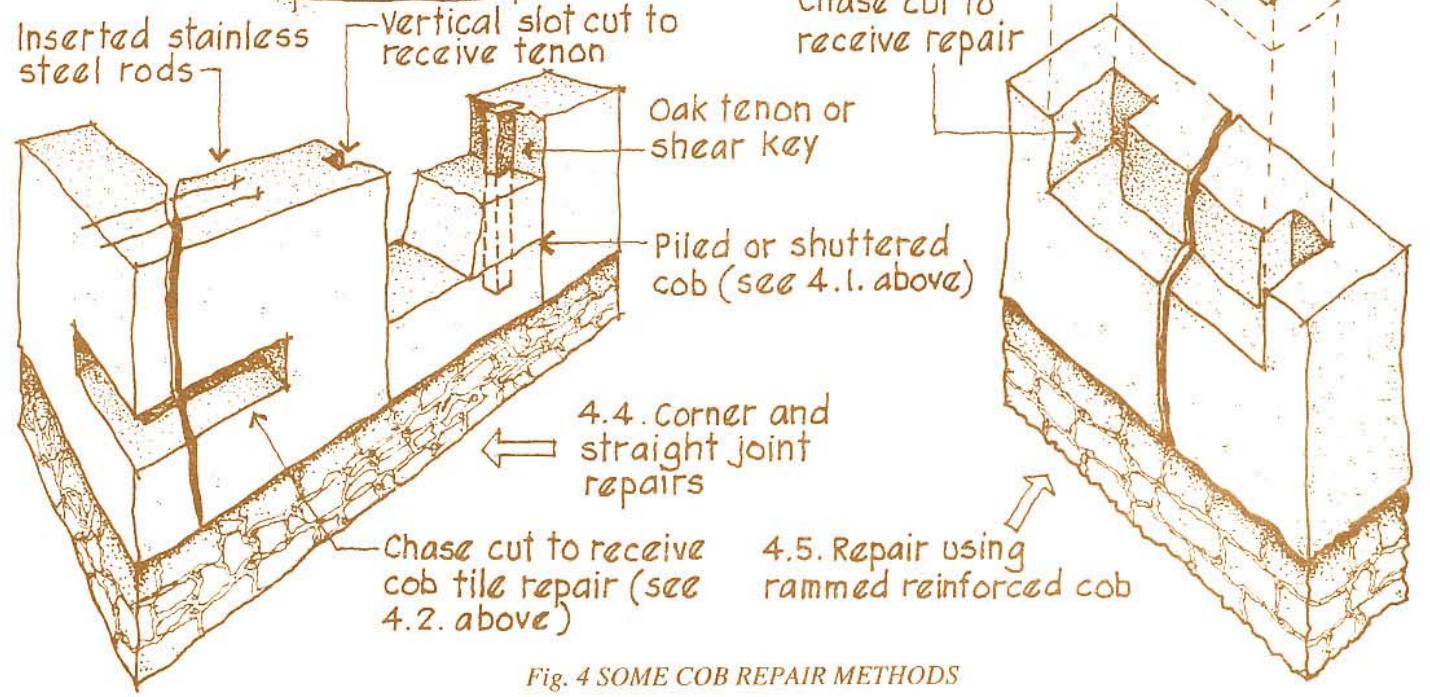
Fig. 4 SOME COB REPAIR METHODS

When rebuilding a section of cob wall it is best to avoid stepped joints (see Fig 4.1) because these will encourage the formation of cracks. Joints between old and new cob should be either vertical or sloped in order to allow for settlement and shrinkage of the new material. In vertical joints settlement can be provided for, while maintaining a mechanical key between the new and the old cob, by the incorporation of a hardwood tenon or shear key (which may also serve as a structural full-height wall post supporting rafters or wall plate). Any shrinkage cracks that develop may be filled by ramming in dampened sieved cob with a steel rod or similar tool. In cases where large sections of wall have collapsed, main floor beams and principal rafters will require structural support. Wall plates should be formed in oak rather than reinforced concrete, and beam ends can be supported on oak posts, masonry or stabilised soil blockwork pillars. For structural repairs the advice of an engineer, surveyor or architect should be sought.

Instead two basic methods of crack stitching, which may be modified to suit individual cases, are suggested: (1) repair using pre-cast cob tiles or cob bricks/blocks, with reinforcement incorporated if required (2) the ramming into pre-cut chases of stabilised cob incorporating metallic or fabric reinforcement. Both methods are shown in Fig 4. The method to be adopted will depend on the location, severity and extent of damage. For example, a structural crack that has been widened as a result of long-term erosion by running water will require extensive rebuilding, so the use of cob tiles or blocks would be the obvious choice. It should be noted that cracks, especially those occurring at wall junctions, will not always be at right-angles to the wall face but may run diagonally (see Fig 4.4).

The first method largely overcomes the problems of shrinkage associated with the repair of old cob with new by using cob bricks, tiles or blocks. These can be fabricated to any desired size using bottomless timber or metal moulds. Manually-operated concrete block-making machines can be adapted for use with cob, and portable block presses, also manually operated, are available. For crack stitching, cob tiles are considered most suitable because they offer a high degree of flexibility and are easily handled. Cob tiles or blocks are laid in bonded courses, in pre-cut horizontal chases, using a technique similar to that of conventional masonry construction, in a mor-

tar comprised of sieved sub-soil, coarse sand and lime putty. Non-ferrous metal lathing reinforcement can, if required, be laid between tile courses. When stitching is complete the remainder of the crack can be filled by lime/sand grouting or by ramming in a cob mix containing only enough water to achieve workability in order to reduce shrinkage to the minimum.

The second method of crack stitching, which involves the use of reinforced rammed cob, is probably less suitable for corner repairs but quite adequate for straight walls. It requires the cutting of chases as for tile stitching but with the addition of returns or rebates, usually cut to half the depth of the wall, at either end of the chase to help anchor the repair. Work proceeds in three stages, with the reinforcement being incorporated at the first and second stages (see Fig 4.5) A standard cob mix, including straw, but with the addition of 5 to 10% lime putty is used. The mix should be kept as dry as possible in order to minimise shrinkage.

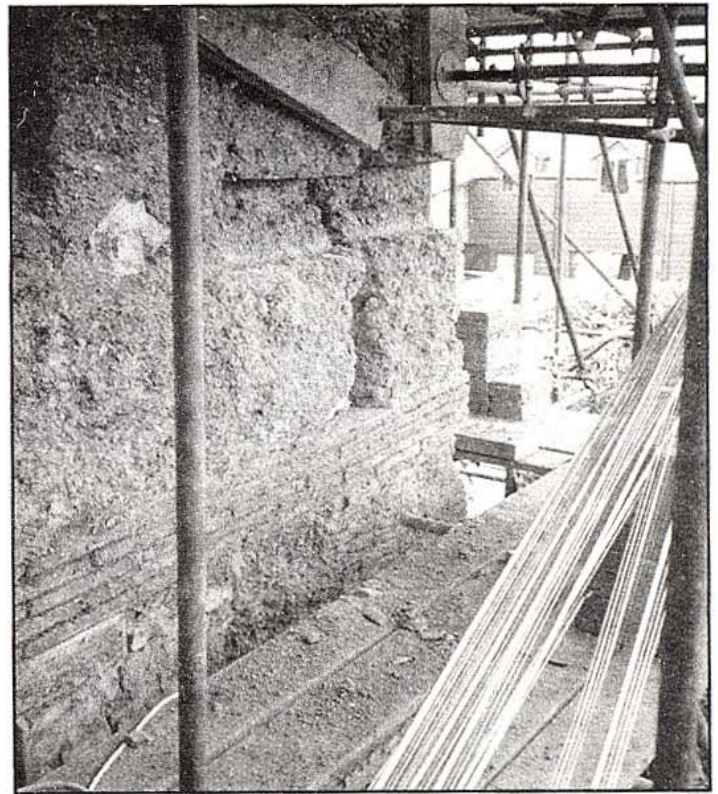
Crack stitching with cob tiles: Town Farm, Gittisham.

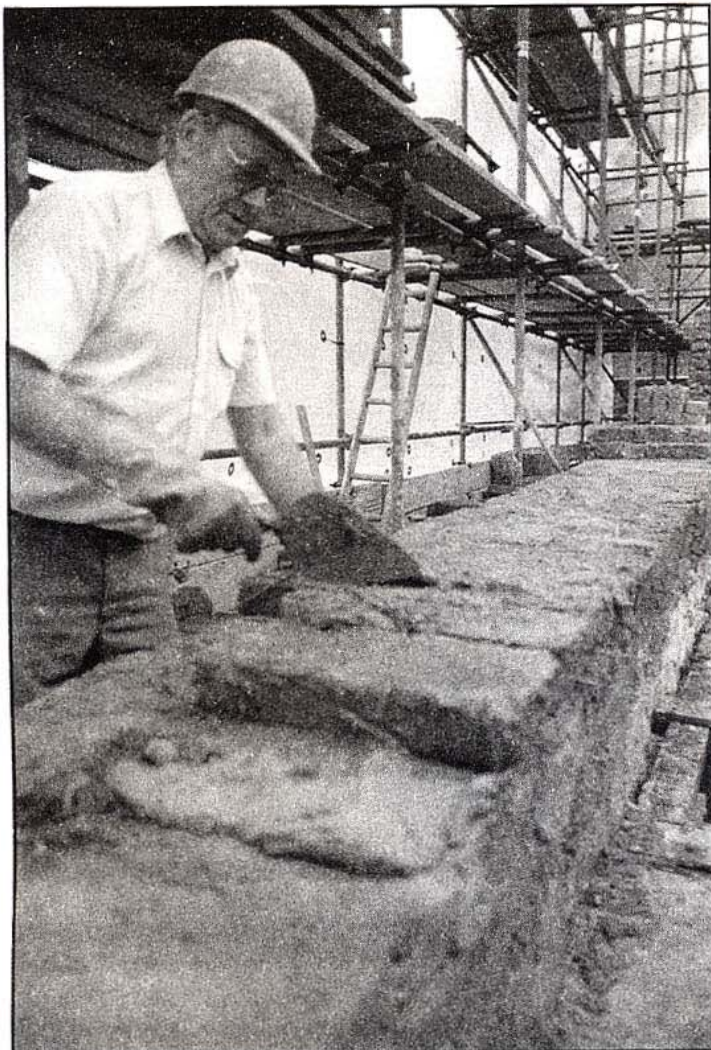
Reconstruction of a cob wall using pre-moulded cob blocks at the Church House Inn, Stokeinteignhead. (Photograph published with kind permission of Architecton and Heavitree Brewery PLC).
