DE BA DEVON EARTH BUILDING ASSOCIATION

Newsletter TWO

THE DEVON EARTH BUILDING ASSOCIATION

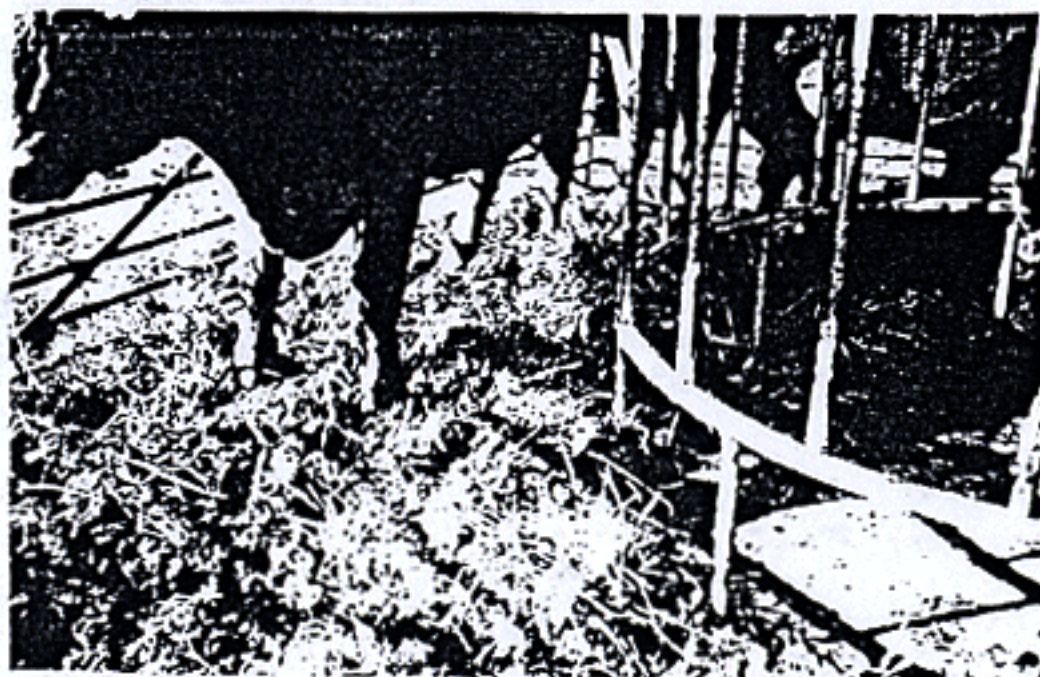
THE MIX

4 BUCKETS OF SUBSOIL (1 bucket = $\frac{1}{2}$ cu.metre aprox)
3 STANDARD BALES STRAW
WATER

The mix was laid in a circle around a cattle feeding pen with alternate layers of straw and subsoil. A hose pipe was used to add water evenly over the top. A pen was then constructed with a series of gates and 3 bullocks (sometimes 5) were used to tread the mix overnight. This produced a workable consistency which was just 'turned over' once or twice by the tractor before using the following morning.

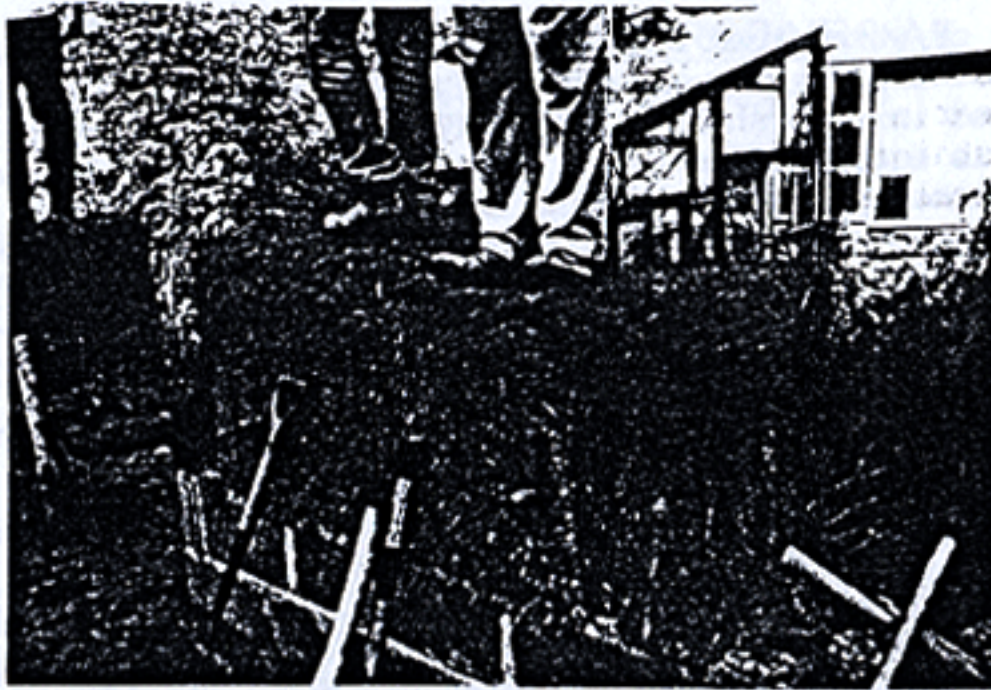
WALL BUILDING

The cob was placed on the wall with pitch forks and trodden down. On average there were 4 people working at any one time. The builders were unable to work round the walls in the traditional way because the number of openings meant that the building was constructed as a series of pillars. The cob was placed in 3 lifts of approx. 660mm each. A week was left between each lift to allow for drying and paring back. The paring was rather time consuming as no formwork was used around the openings. Pieces of timber were set into the edges of the openings, at intervals, to be used as fixings for windows and doors.

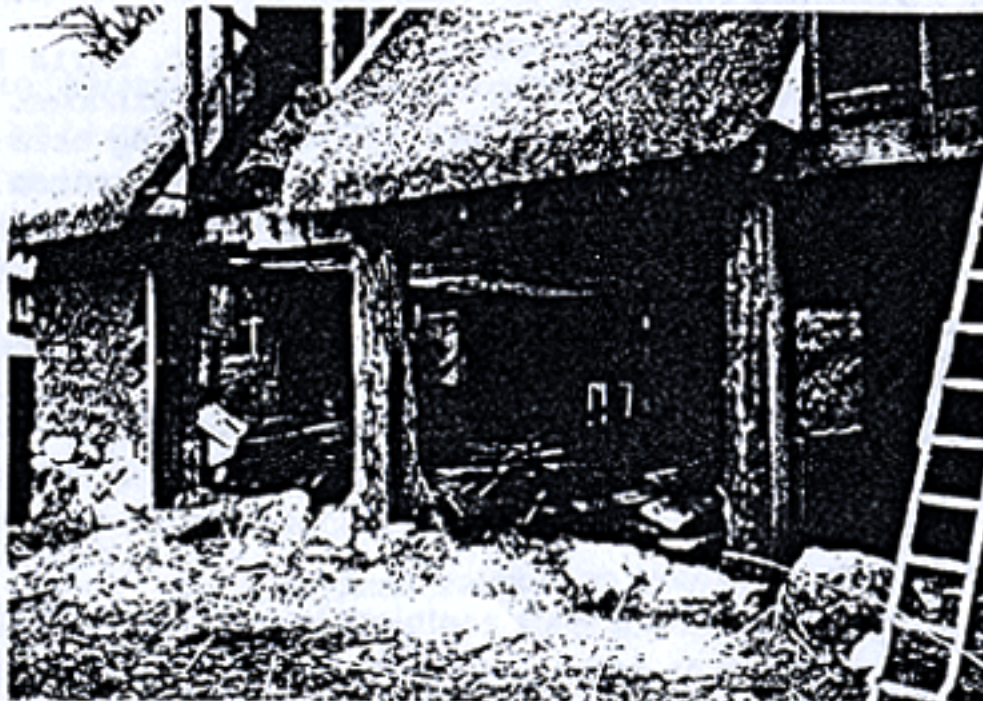
THE TIMBERWORK

It was decided to keep the front of the building as open and as light as possible. Large oak pillars were rough sawn from trees found on the farm. These formed support at the front and also within the structure. Tressel pieces were pegged into the cob and the lintels then laid on these without further fixing. A timber wall plate 230mm x 80mm was placed around the whole building before floors and roof structure were commenced. Joist graded timber was used for the floor and second hand timber for the construction of the purlins and rafters. The roof pitch is 50°. The main timber work was carried out in only 9½ days.

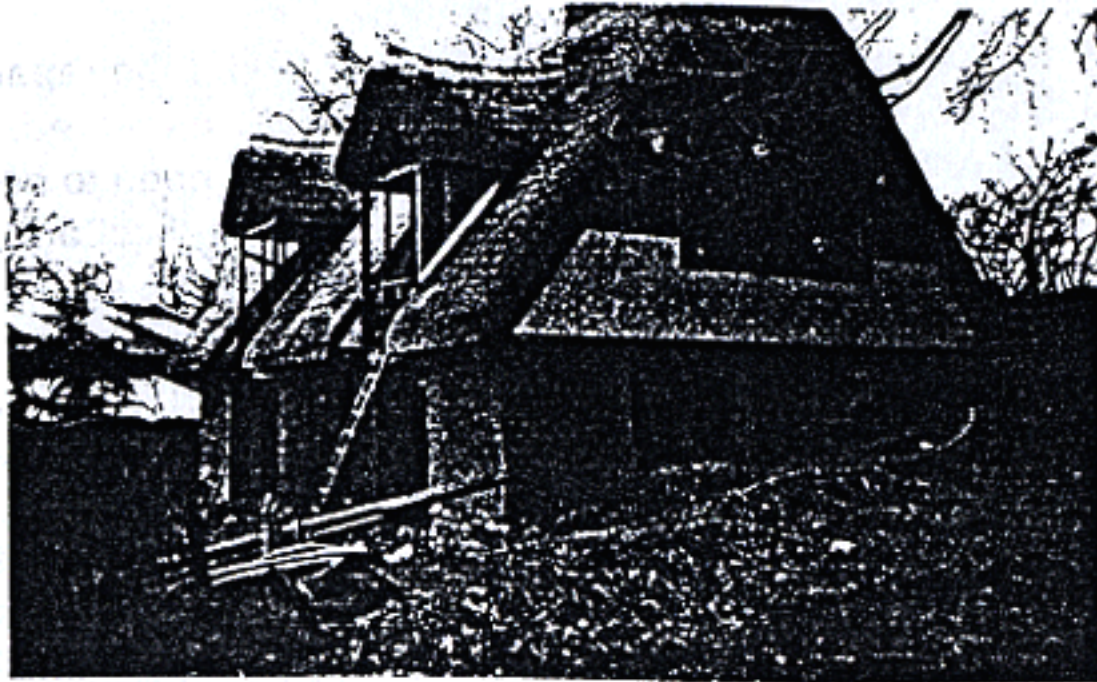
GABLE ENDS

It had been envisaged at one stage, that the gable ends should be constructed in cob. However it has been decided to use timber. The offcuts from the oak pillars will be used as weatherboarding or horizontal slats. The Window openings are being constructed in timber to fit second hand windows which the owners are collecting.

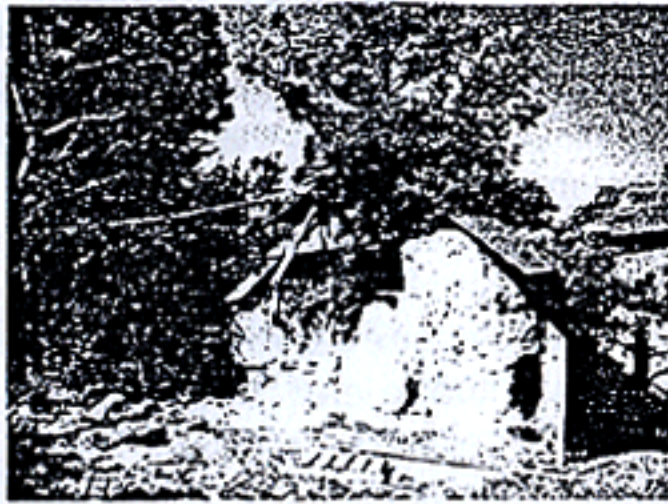
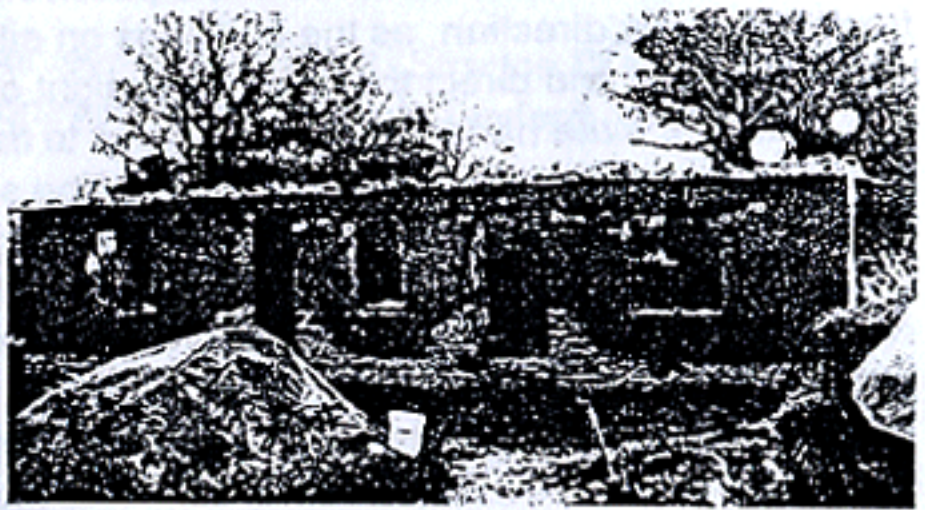
The two above pictures show the derelict barn as it was and the new building as it is at the moment (2/96) without a roof.

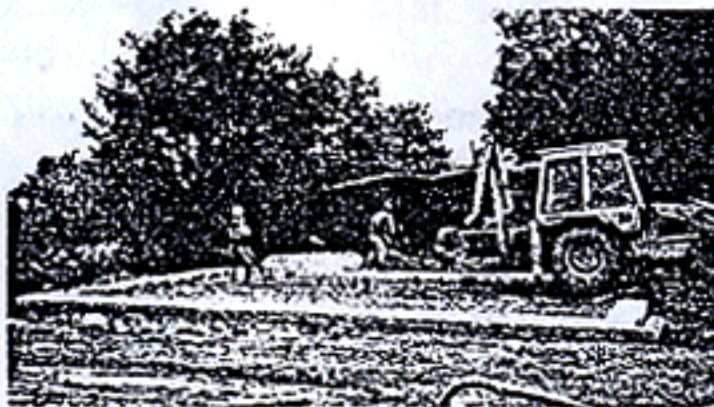
The foundations were laid in two levels. Excessive moisture and low stone content were found in the surrounding subsoil at the eastern face. This meant that the foundations had to be dug a further 300 mm. Hence one half of the foundations are approximately 225 mm lower than the other.

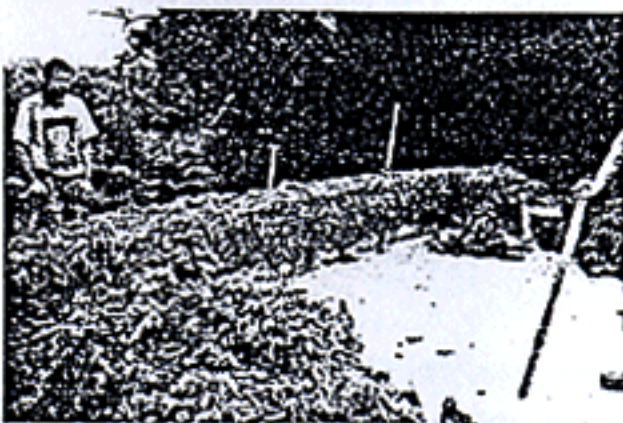
The first Cob mix was found to have an excessive moisture content, partly due to rain at the time of mixing. A small amount of this was used but found to be generally useless as it was far too plastic and bulged greatly at relatively low lifts (e.g. 300 mm, See adjacent picture). A second mix done on the first day was found to be more satisfactory but still the moisture content was too high.

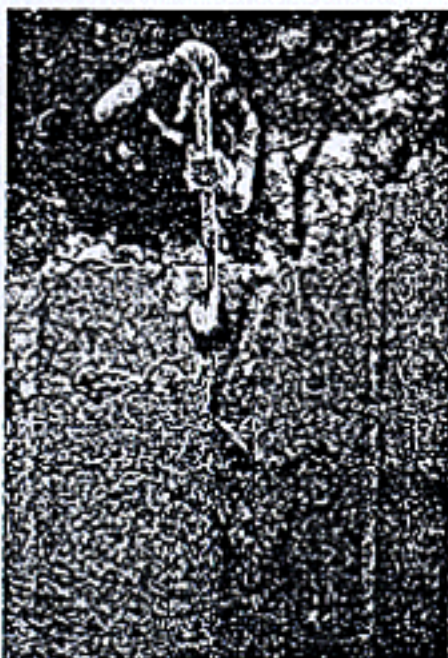
Paring

Most of the paring was carried out from above, after each lift, with a sharpened, flattened garden spade. It cut through the cob with great ease, moreover cut the straw at approximately 25 mm from the surface of the wall. This enabled any water in contact with the wall to run off the straw ends instead of continuing down the surface. This what happens with thatch and not only protected the surface of the wall but gives a superb key for any applied render or limewash..
