**DE
BA** **DEVON EARTH
BUILDING
ASSOCIATION**

**Newsletter 4
Summer 1997**

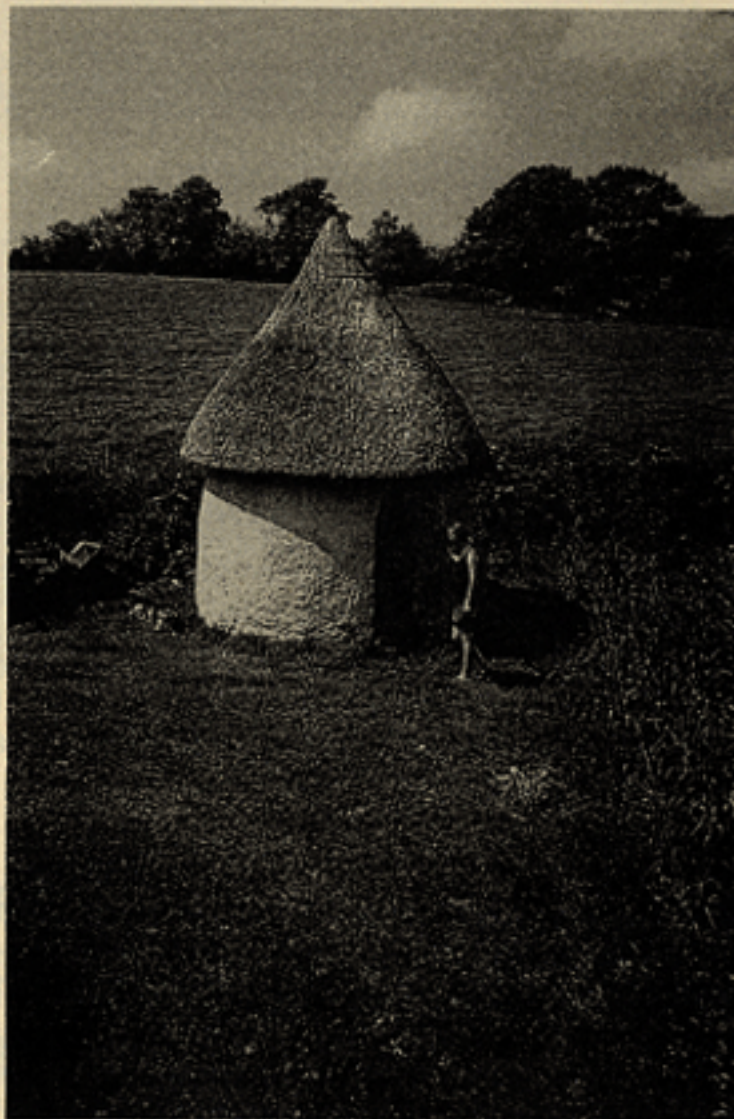
THOLOS AT LOWER TRICOMBE

Erosion on my tholos (no this is not a medical condition - see Newsletter No. 2) has been more troublesome. Not exactly erosion, but deterioration of the render due to the very exposed nature of the walls and possibly compounded by being forced to render the same autumn that I completed the egg shaped building. Substrate movement caused hairline cracking which of course invited more water in thus softening and expanding the cob below, which in turn opened up the hairline cracks thus creating a vicious circle. Several attempts at lime slurring the cracks (normally very successful in a vertical situation) proved ultimately unsuccessful. Although the building stood up fine without added protection despite these problems, I have decided to admit defeat early on this one as it is a very useful building to me and I don't want it to suffer unduly in its early years. I have therefore recently completed a thatched roof which has been crooked onto the cob with extra long crooks, which means we have no timber roof structure at all.

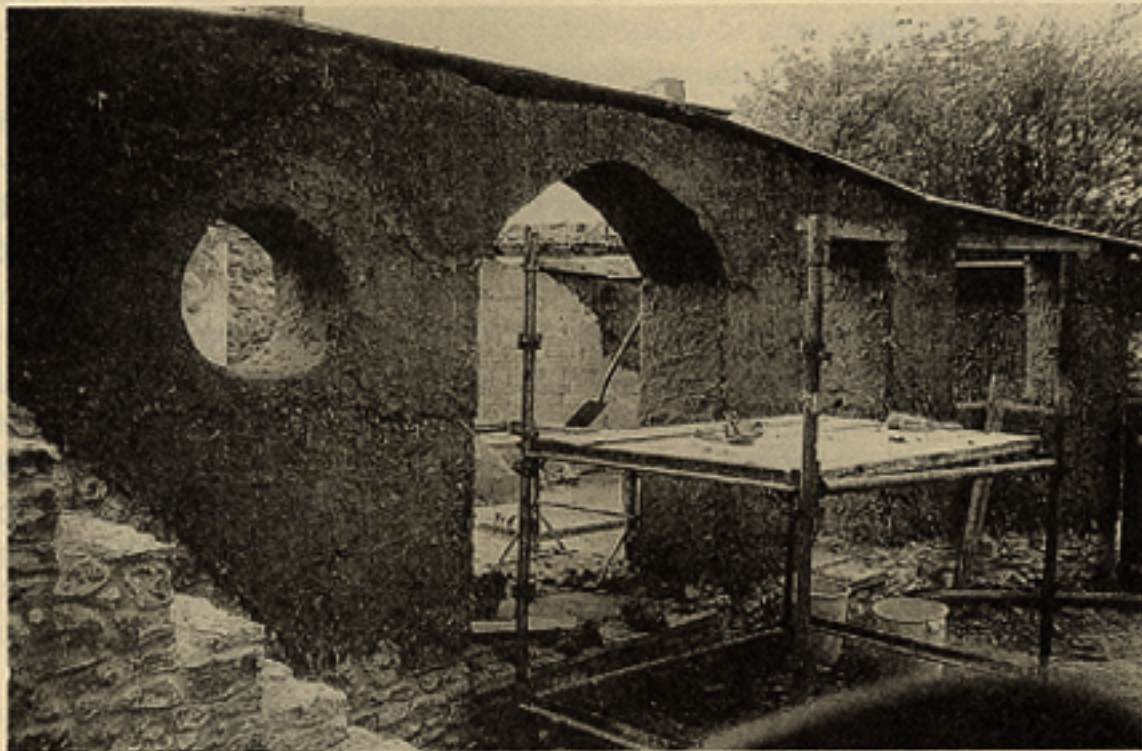
LOWER TRICOMBE

My own buildings: two storey workshop/store and an open fronted cart shed, have gone very well, although again pressure of having to earn a living has meant that I have not had time to finish both, I have managed just to get a roof on the cartshed. I have tried to design both buildings along traditional vernacular lines as well as fitting in harmoniously with their immediate environment. I have also managed to incorporate one or two slightly radical ideas such as a five and a half feet catenary arch over my workshop double doors, and an eight feet high two feet wide cob pillar supporting the main roof truss on my cartshed. The cob work proved visually pleasing and economical as expected.

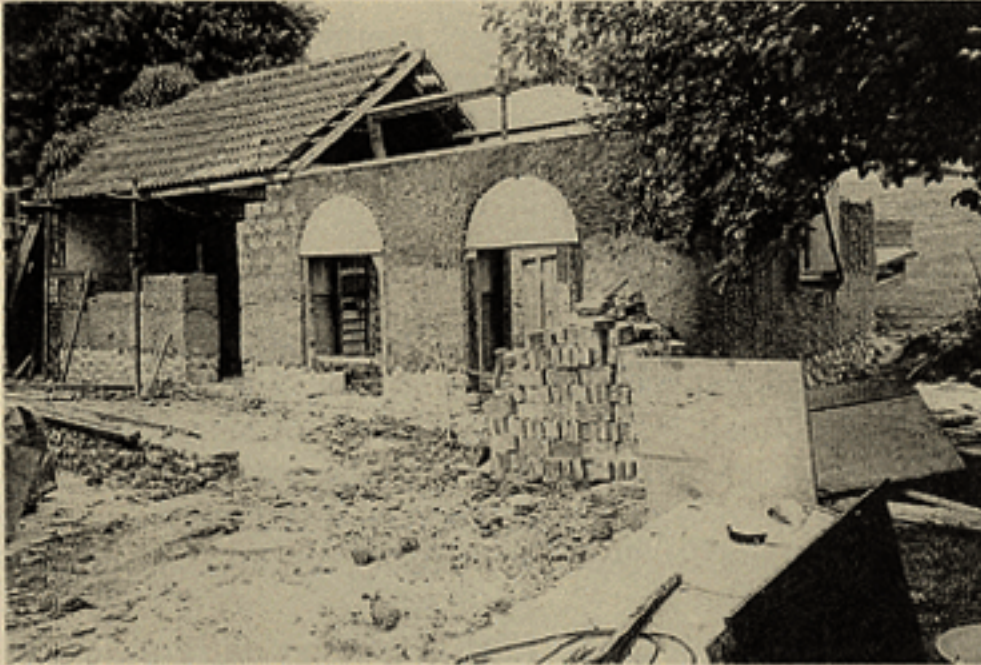
POTTLELAKE

Other work this year at Pottlelake near Shute in east Devon, has again been very successful. This included a single storey extension to a listed grade 2 (partly cob) cottage. Due to the site conditions and client requirements from the new room we had an interesting task designing a shape to make the most of all the relevant criteria not least of which was obtaining listed building consent. We ended up with a rather organic off-set voluptuous lump for which cob was the ideal medium. My client has a particular fondness for cows: the cottage containing hundreds of them in various forms and representations, mostly humorous. She asked part in jest if I could build her one in cob. I thought about it for a while and came up with idea of a jelly-mould type relief and so it was we went ahead; there not being room for a full size Friesian, we are calling the result a Dexter (in fact she has been called Rose but I won't go into all of that). We were both pleased with the slightly understated result.

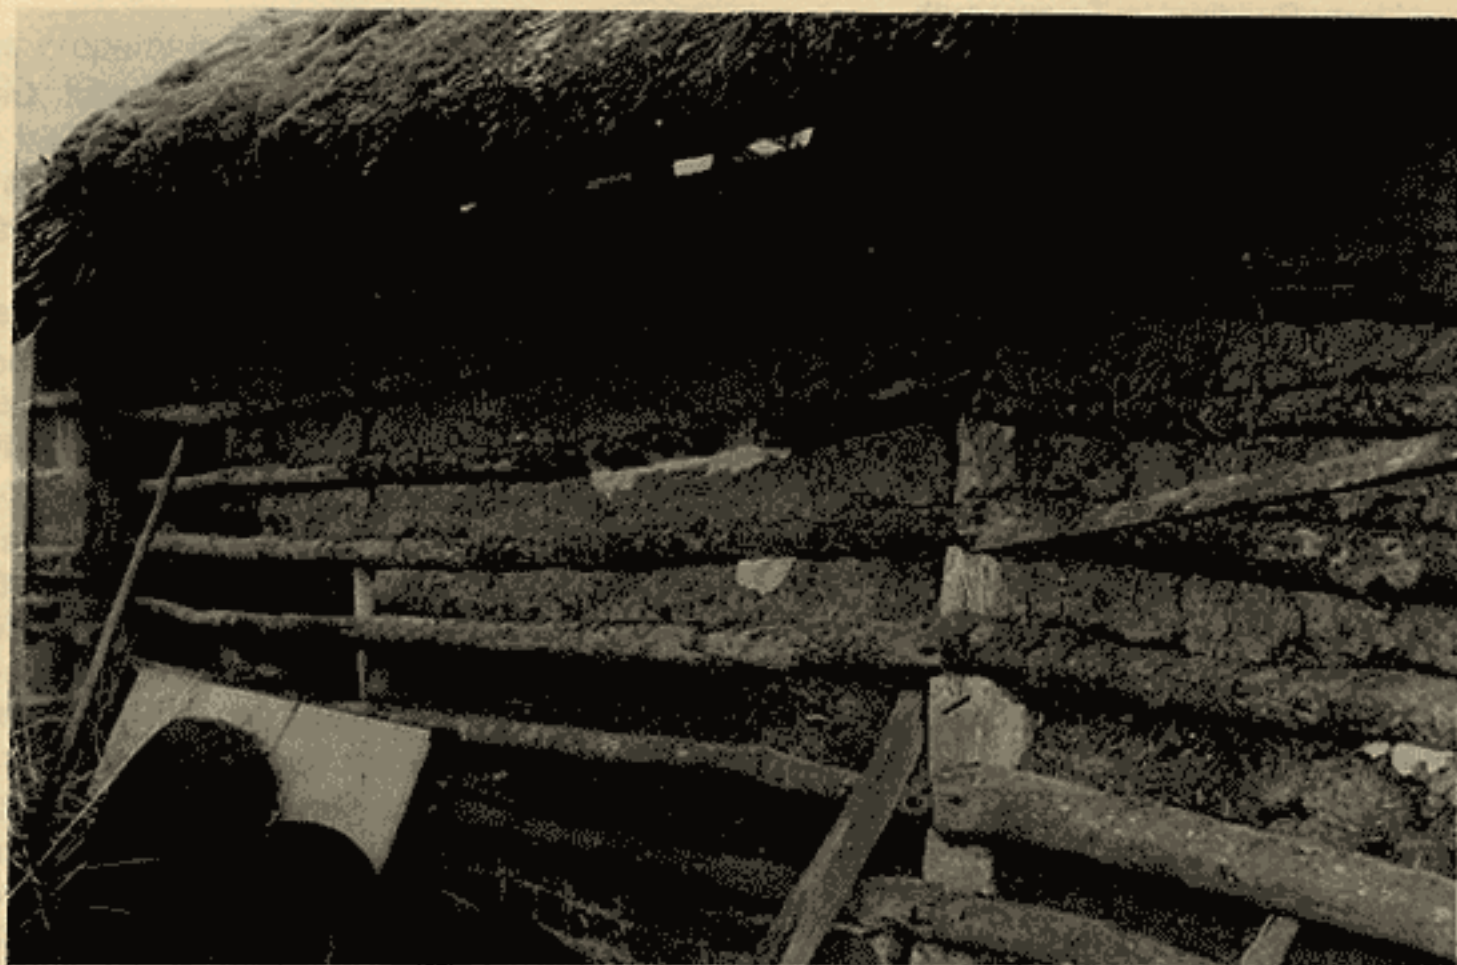
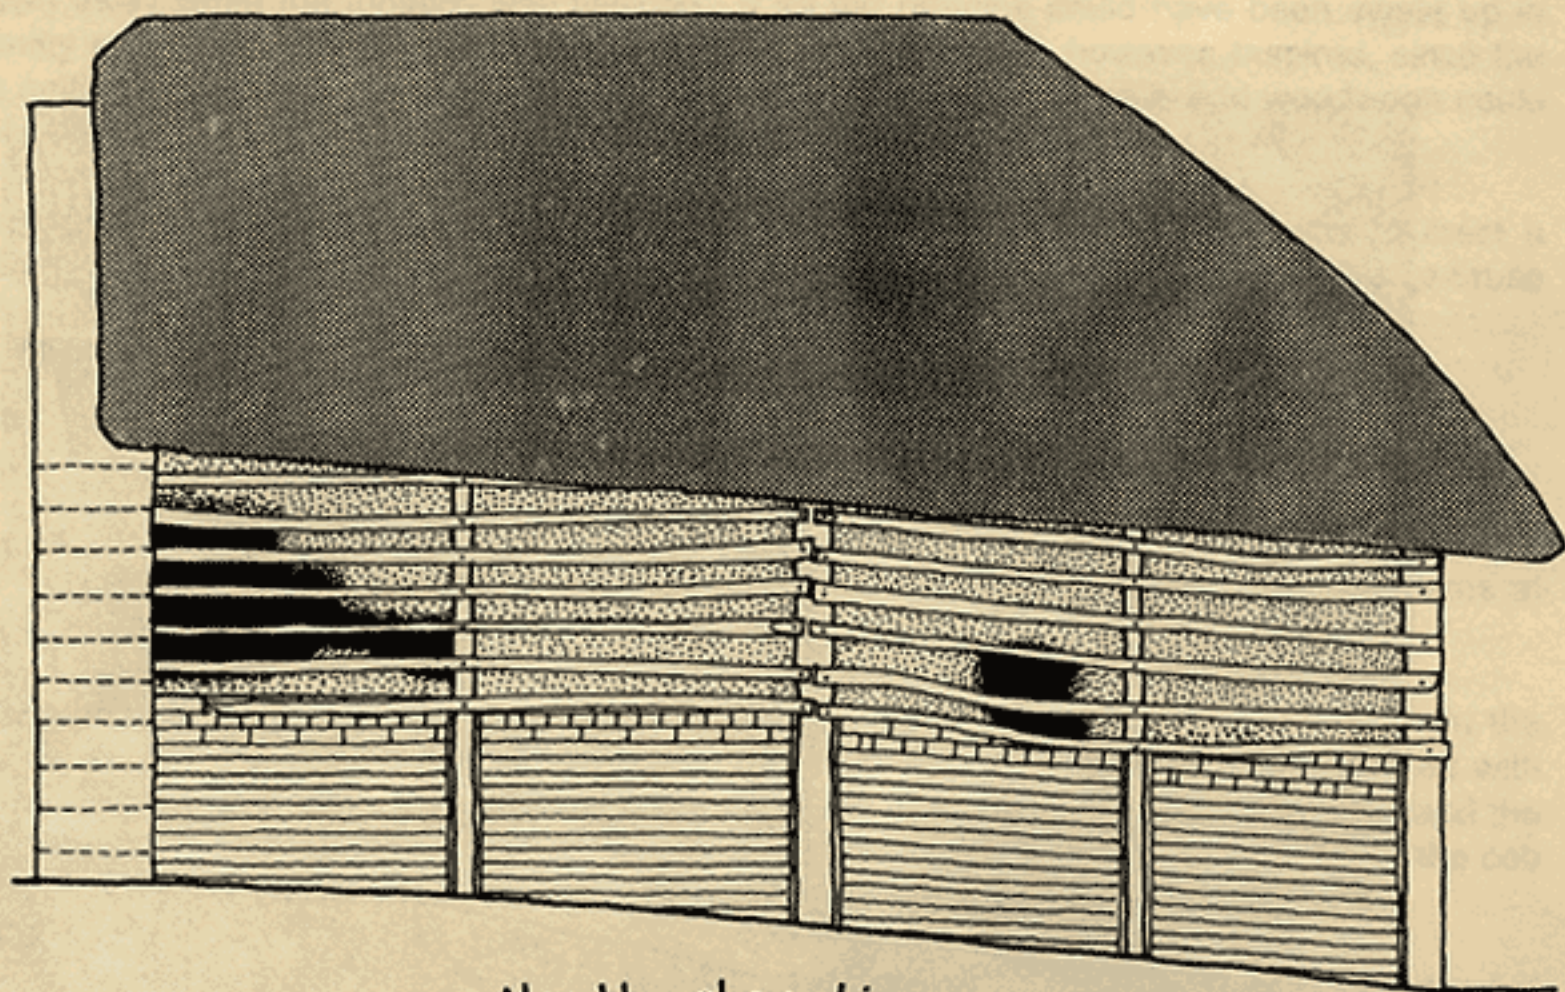
BARN at GITTISHAM FARM

The building must have been constructed some time between 1840 and 1885. Most of the timber used, apart from numerous replacement rafters and thatching battens, is rough-hewn and far from straight or uniform in size. This was clearly a building erected at minimum cost to a

North elevation

very low specification. The only exceptions to this are the two surviving roof trusses, which were clearly salvaged from an earlier building (probably of early 17th century date).

From the brickwork up to the wall plate, average height around 1.40m, is found the building's most interesting feature - slender panels of cob, varying from 100 to 150mm in thickness, set between horizontal 'rails' formed from rustic (un-trimmed) split poles, probably some kind of pine. Only one other such building has been noted in Devon, near Sidmouth, six or seven miles south of Gittisham. However, one of the farm-hands at Gittisham Farm claims to have seen a shippon of similar construction at St. Dominick in east Cornwall (now demolished).

As is often the case in Devon, the roof pitches are rather shallower than is normally considered appropriate. However, wheat reed for thatching has always been grown on the estate, and still is, so fairly frequent replacement would have presented no problem.
